Subject: Department of Natural Resources Washington Geological Survey,
School Seismic Safety Assessment Project, Contract No. AE 410 -
Seismic Evaluation for **Index School District**

1. Index Elementary School, Enclosed Covered Play
2. Index Elementary School, Main Building

Index, Index Elementary School, Enclosed Covered Play

Index, Index Elementary School, Main Building

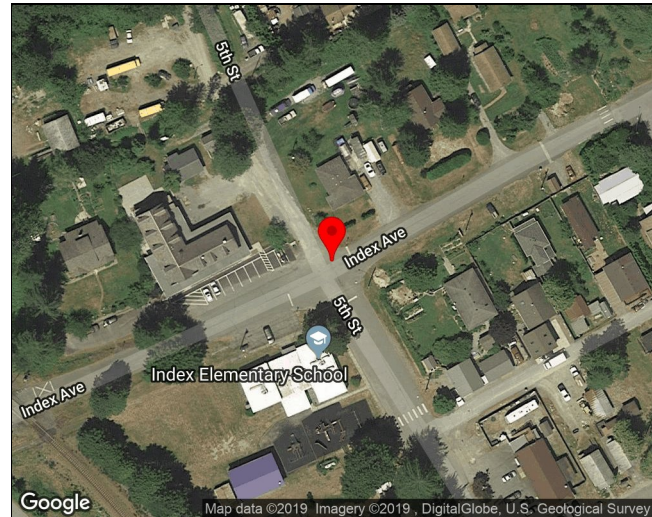
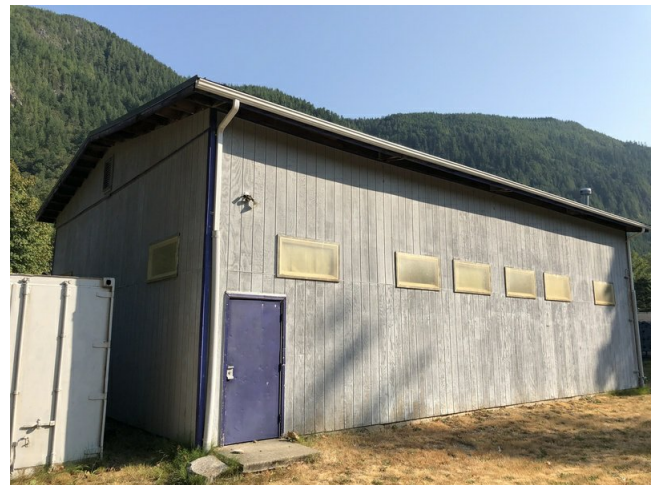
This 30 ft by 46 ft rectangular building is a single-story wood framed building with a pitched roof. There are three built up steel trusses supported by 6x6 wood posts and OSB panelized wood shear walls on shallow spread footings.

Typical nonstructural components consist of gym equipment, suspended mechanical equipment, suspended speakers, acoustical panels and lights. No fire suppression system was observed in the building. The building also houses a wood-framed stage area for theater use.

Structural System	Description
Structural Roof	No visible signs of damage or deterioration .
Structural Floor(s)	No visible signs of damage or deterioration .
Foundations	The foundation elements were not directly visible, as they are buried in the ground. In general, the building appears to be level, with no signs of distress from differential settlement, likely suggesting the foundations appear to be in good condition.
Gravity System	No visible signs of damage or deterioration .
Lateral System	No visible signs of damage or deterioration .

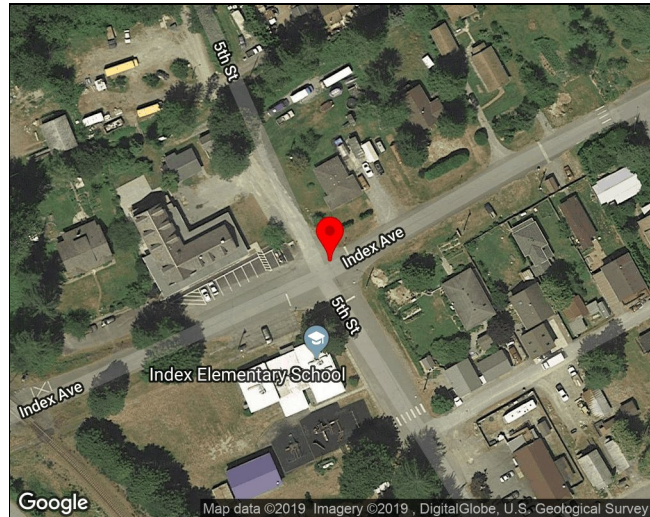
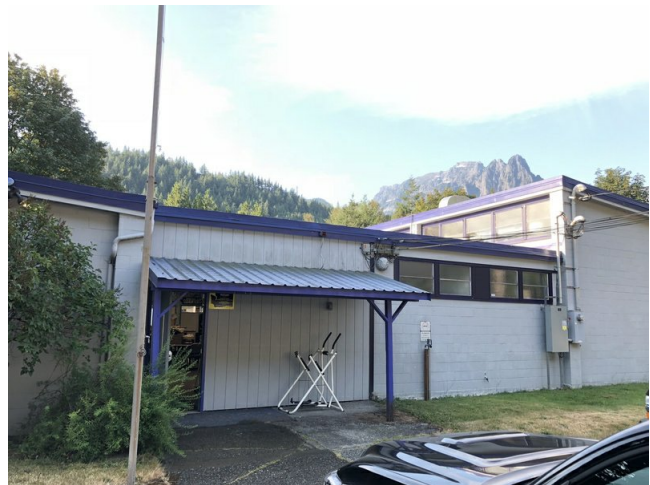
The one-story masonry building is comprised of three sections: a multi-purpose room on the west side, two classrooms on the east side, and administrative, mechanical, and restroom spaces in between multipurpose and classroom areas. The multipurpose and classroom areas were formerly two separate buildings, until a remodel infilled and covered the former outdoor area in between the buildings to create interior space. The roof over the classroom and multi-purpose areas are framed with steel bar joists at 48" oc that support gypsum panels. An interior masonry wall separates the two classrooms and the east exterior wall of the classroom area has three segments of wood shear walls that was added as part of a renovation. Bands of windows just below the roof diaphragm occur along the east and west (longitudinal) masonry walls of the original classroom and multipurpose buildings just below the roof. The roof over the middle shared area is framed with wood T&G decking over 4x12's @ 48" oc.
